ADVANCED MATERIALS TECHNOLOGIES

Antierosion Coatings

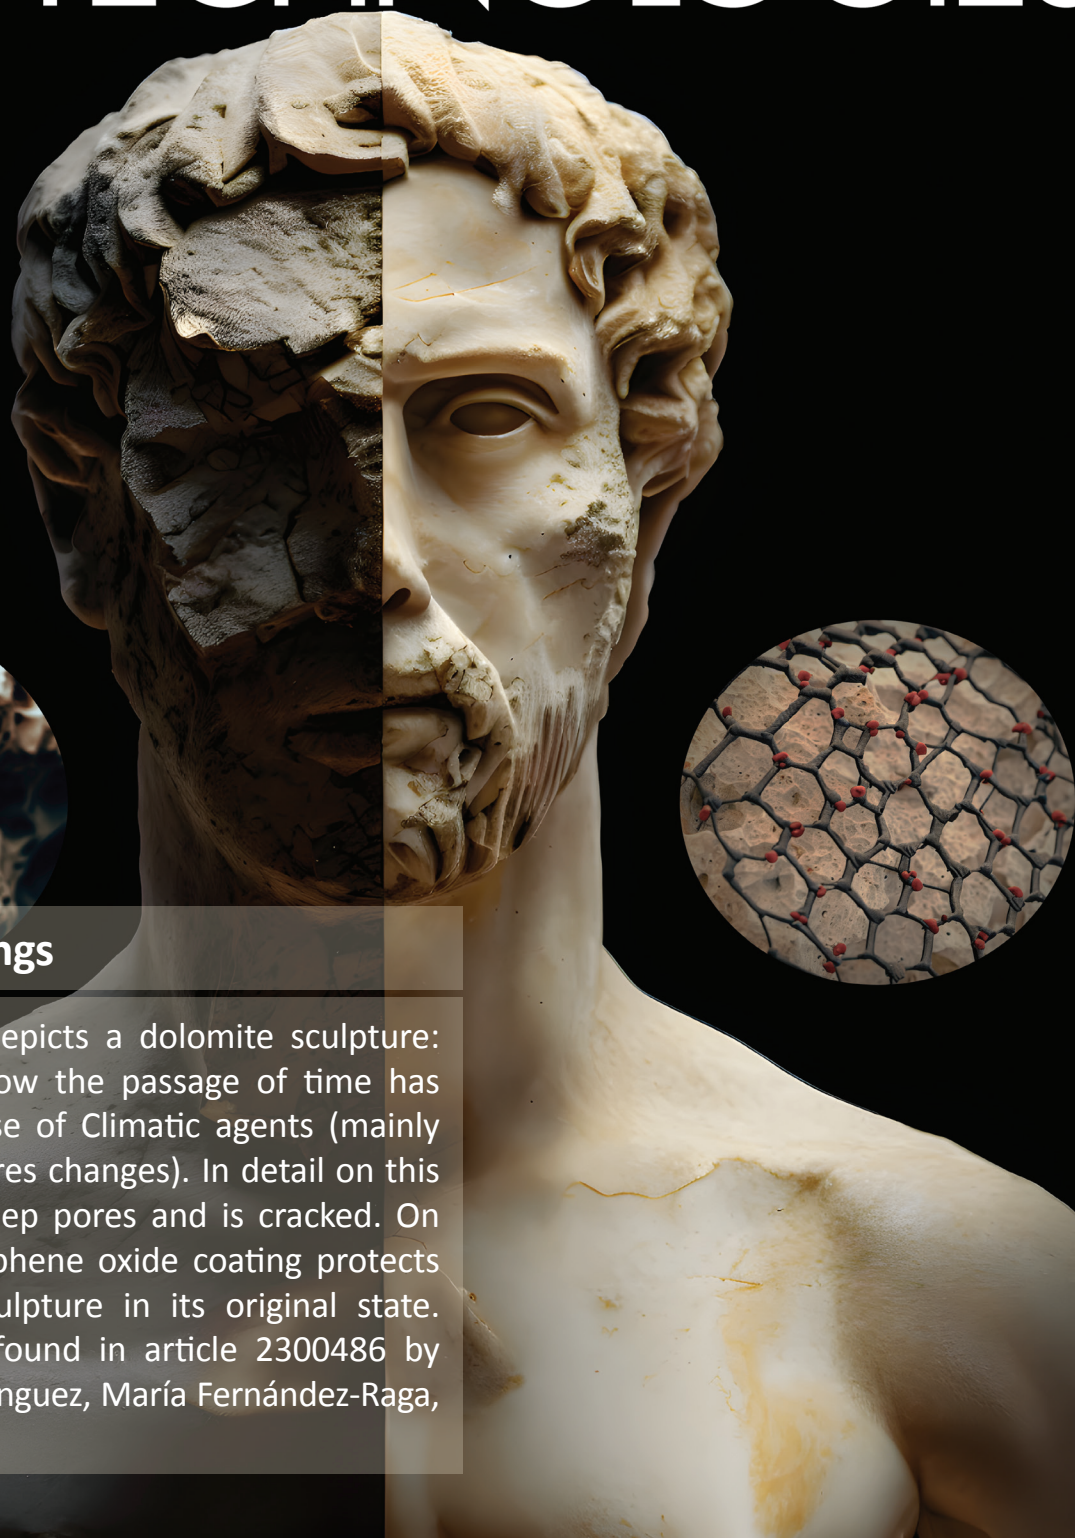
The proposed cover depicts a dolomite sculpture: The left half shows how the passage of time has caused erosion because of Climatic agents (mainly rainfall and temperatures changes). In detail on this side, the stone has deep pores and is cracked. On the right half, the graphene oxide coating protects and preserves the sculpture in its original state. More details can be found in article 2300486 by José M. González-Domínguez, María Fernández-Raga, and co-workers.
