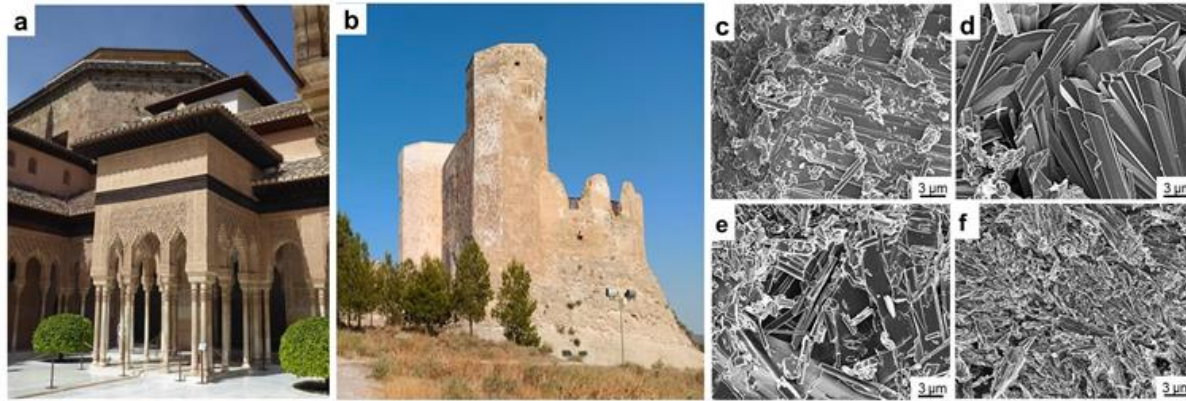
Fig. 1. Images showing the versatility of traditional gypsum used for a) decorative plasterwork at the Alhambra fortress (Granada, IV century) and b) mortars and renders at the Ayyub castle in Calatayud (Zaragoza, IX century); and electron microscopy images of gypsum plasters prepared with gypsum calcined at c) 100°C containing mainly uncalcined gypsum; d) and e) 200°C showing typical gypsum crystals formed after hydration and some uncalcined gypsum, and f) 400°C showing feather-like unhydrated anhydrite II crystals.

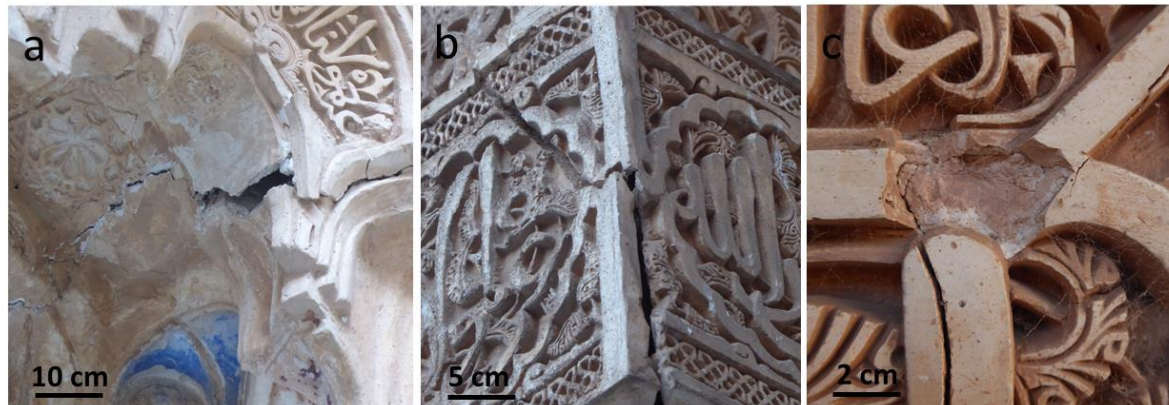
Fig. 2. Decorative gypsum plasterwork (yesería) at the Alhambra fortress (Granada, Spain) showing crack formation and material loss, evidencing the need for compatible replacement materials.
